SAS Superstructure

Daily Diary Report by Bid Item

Contract No.: 04-0120F4

Diary #: 291 Const Calendar Day: 595 Date: 26-Apr-2011 Tuesday

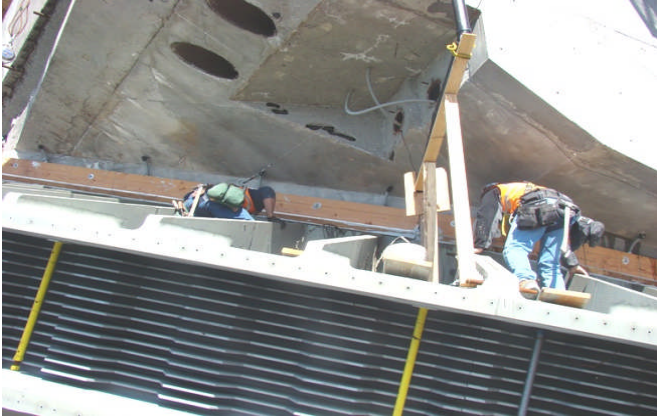
Conco carpenters sealing the formwork on the top of the middle section of the W2W west deviation saddle formwork.

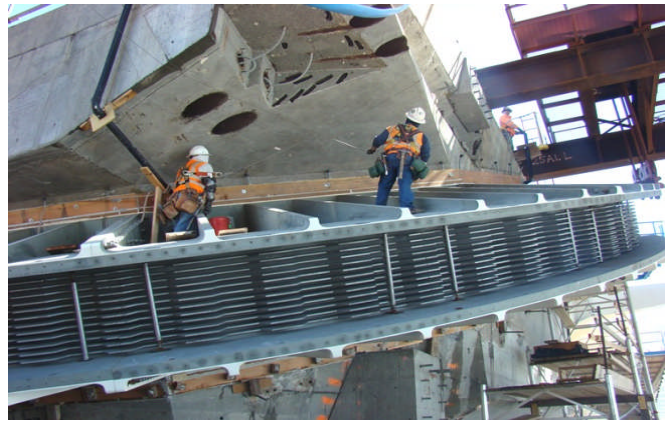
Conco carpenters monitoring the formwork for any leaks on the top side of the W2E west deviation saddle.

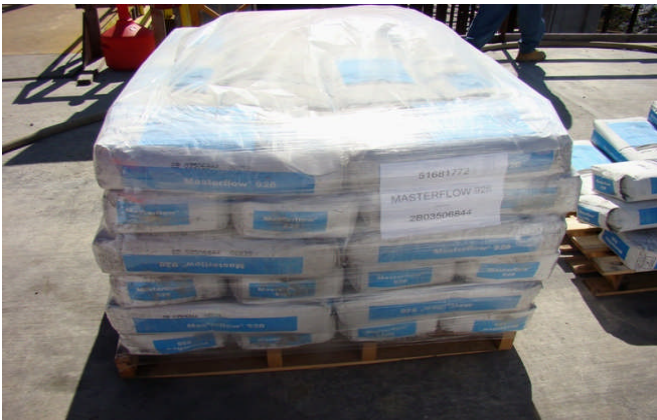
Due to the limited supply of cementitious grout ABF had 55lb bags onsite which appeared to be weathered and hardened.

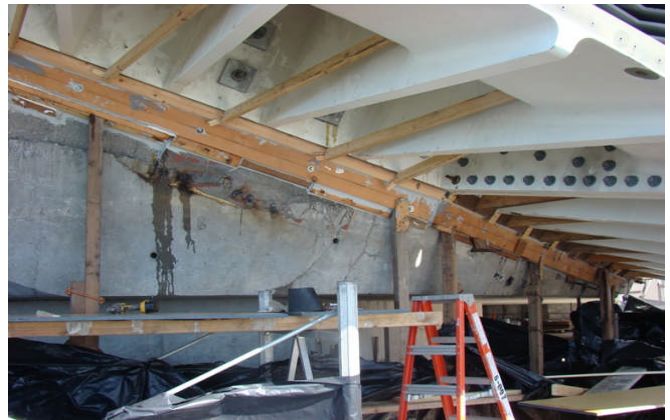
Additional kickers/braces placed prior to grout placement at the W2W west deviation saddle given the form blowouts on the W2E forms.

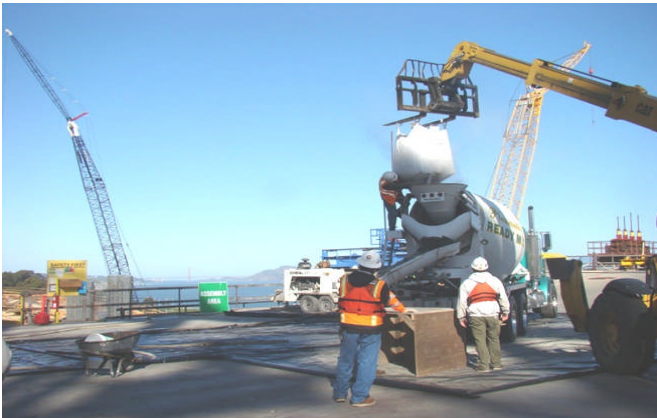
The grouting operation for the west deviation saddles began approximately around 8:45am.

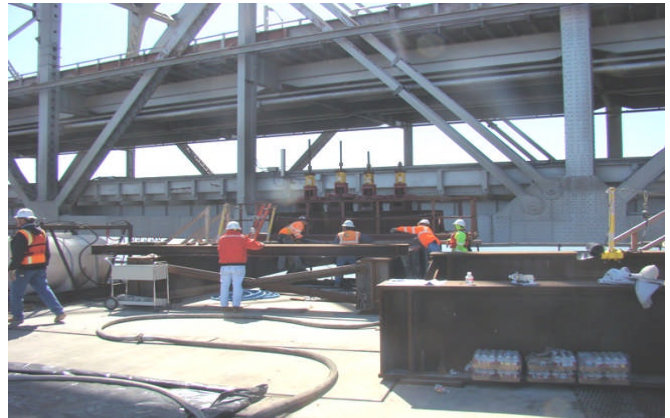
Conco laborers placing grout into the top inlet port for the W2E west deviation saddle grout pad.

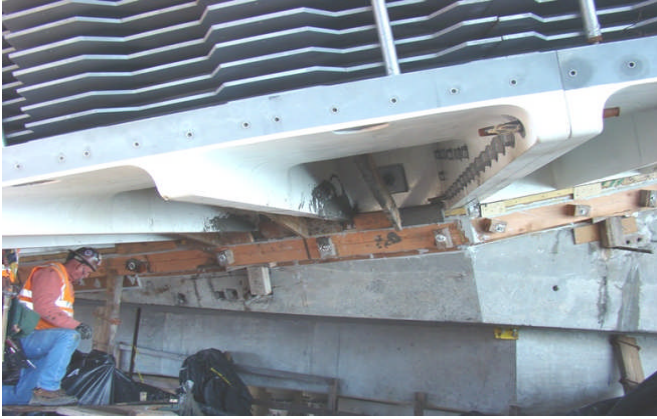
Conco carpenters took approximately a half an hour to seal the forms prior to resuming grout placement in the W2E west deviation saddle.

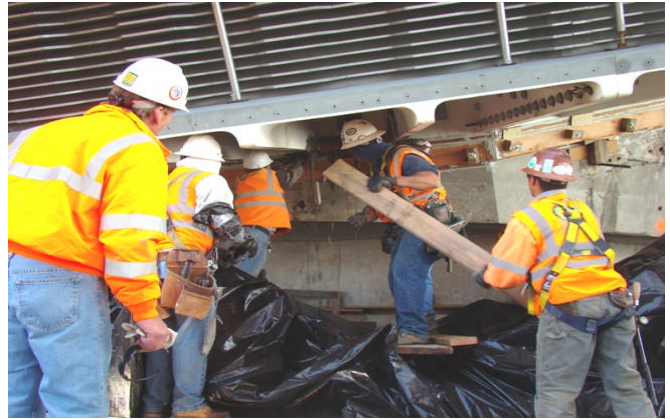
occurred
Similarly
at the W2E west deviation saddle formwork, one on the top and one on the bottom.

First leak/form blowout of the day on the bottom of the W2E west deviation saddle formwork on the bottom 1/3 section of the saddle segment assembly.

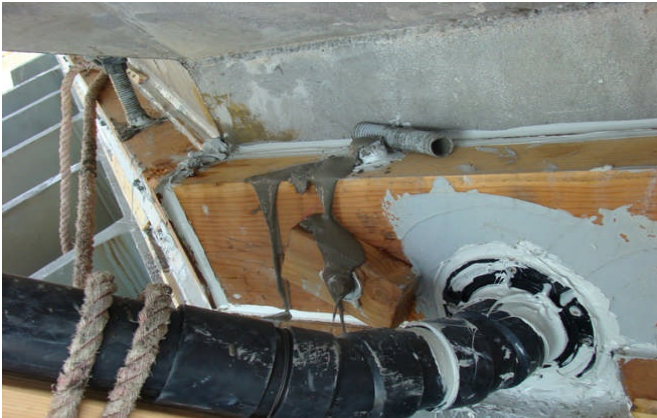
Grout seen coming out of the top of the top of the W2E west deviation saddle formwork for the second time after the first major leak.

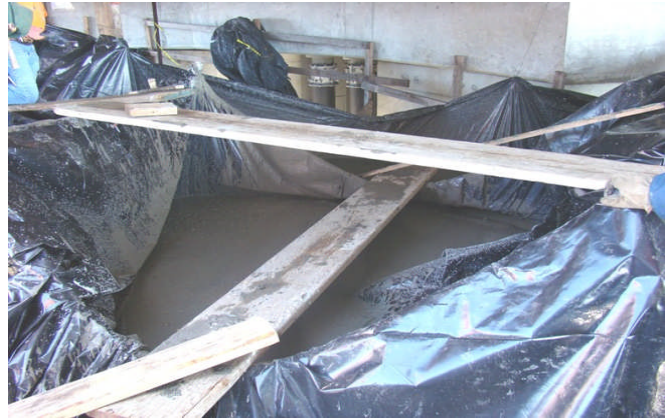
It was estimated that one to two cubic yards were discharged from the forms from the first leak at the W2E west deviation saddle formwork.

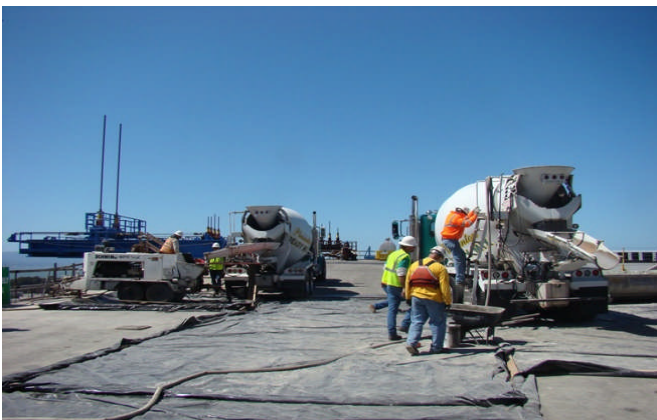
Mixing operation on top of the W2 cap beam which appeared to provide efficient grout to the forms.

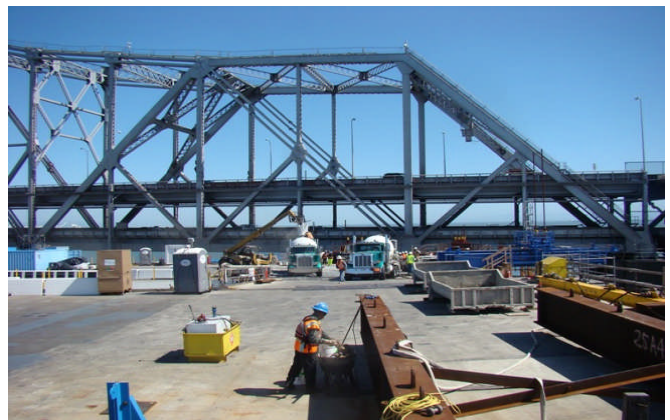
- 1.) The quality of the grout appeared to be good as mixing was consistent and dependent on the temperature. Large clumps of grout were observed coming down the Ready Mix truck chute at times which was filtered with the screen on the hopper.

Ready mix trucks placing and making grout.

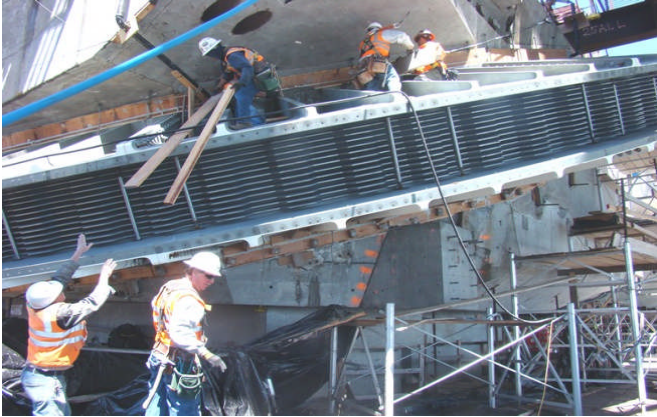
The 2nd grout leak in the W2E deviation saddle forms occurred at 1:00pm (4hrs into the grout placement) as Conco carpenters & laborers began repairs

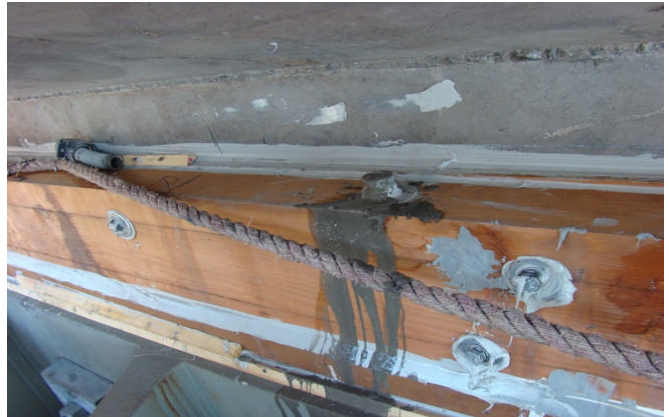
After the first leak grout had to ejected through the outlet ports again to ensure proper placement.

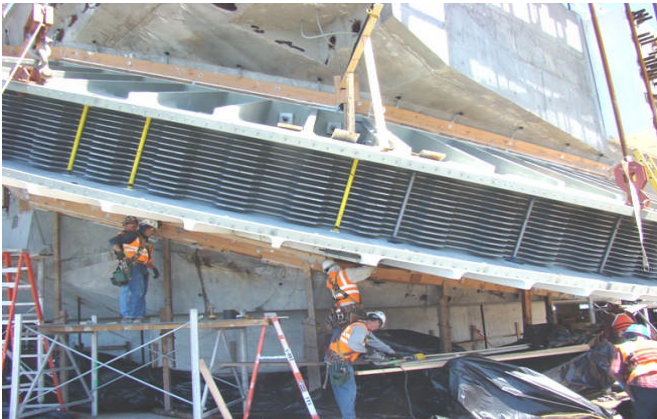
Conco carpenters constructing additional forms/braces to help provide support for the formwork already in place.

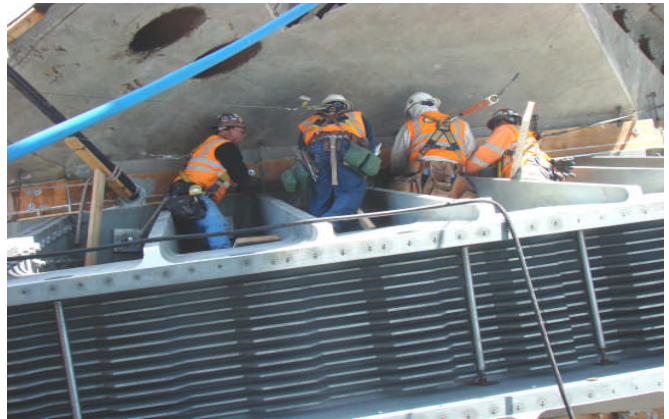
Conco carpenters & laborers began repairing the second grout leak in the W2E deviation saddle forms.
